Products Involved:
Sportsound 500HD, 1500HD, 2000HD

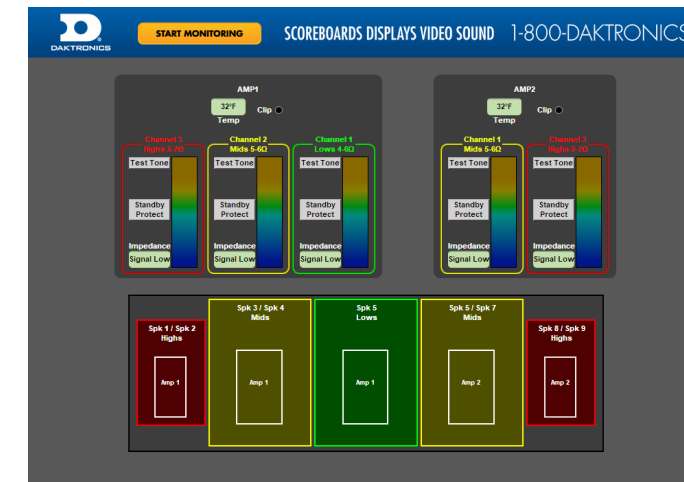
4 & 5. 500HD Monitor

4. Open Monitor Panel for the Sound System and Test Amplifier/Driver Output	<p>*Sportsound Monitor Panel must be installed on laptop* If not, go to dakfiles.daktronics.com to download.</p> <p>Open the Monitor Panel for the system and click Start Monitoring.</p> <p>Play a full-frequency audio file through the system. Verify each amplifier/driver combo is outputting audio by first placing all Amplifier Channels in Standby, then one at a time, unmute them. If you hear audio playing for the channel that is unmuted, the amplifier is outputting audio.</p>	<ul style="list-style-type: none"> Monitor Application Operational Video Dakfiles Monitor Panels Software Download Link

5. Verify Impedance Values of Drivers are Within Range	<p>Audio levels get loud during this test. Proceed with caution. Play a test tone to each amplifier by clicking Test Tone.</p> <p>The Test Tone is played for 4 seconds and then it automatically shuts off. Repeat as necessary. Impedance values fluctuate at first and will stabilize at the end of the tone. Pay close attention and use the last value shown. Check both values on dual channel amps.</p> <p>Take a screenshot of all amplifiers in Test Tone mode at once to submit in deliverables.</p> <p>Reference the range shown at the top of each channel for correct values.</p> <p>Double Impedance Value = Blown Driver or Bad Connection Signal Low = No Sound = Blown Amp Channel, All Drivers Blown on Channel, or Bad Harness Connection Short = Short in Connection</p>	<ul style="list-style-type: none"> Monitor Application Operational Video

Task (Major Step)	Process / Key Points / Reason Why (if applicable)	Tools Required / Reference Materials
6. If Problems Found	If impedances do not match the reference values shown, refer to the Amplifier Troubleshooting section in the Sportsound Amplifier Field Guide or the Driver Troubleshooting section in the system Installation Manual.	<ul style="list-style-type: none"> 500HD Installation Manual 1500HD Installation Manual 2000HD Installation Manual
SO/Contract #:	Technician Name:	Date:
